## **Parke's Castle, Co. Leitrim: archaeology, history and architecture**

Foley, C., & Donnelly, C. (2012). *Parke's Castle, Co. Leitrim: archaeology, history and architecture*. (Archaeological monograph series ; 7 ). The Stationery Office, Dublin.

CLAIRE FOLEY AND COLM DONNELLY (L/C)

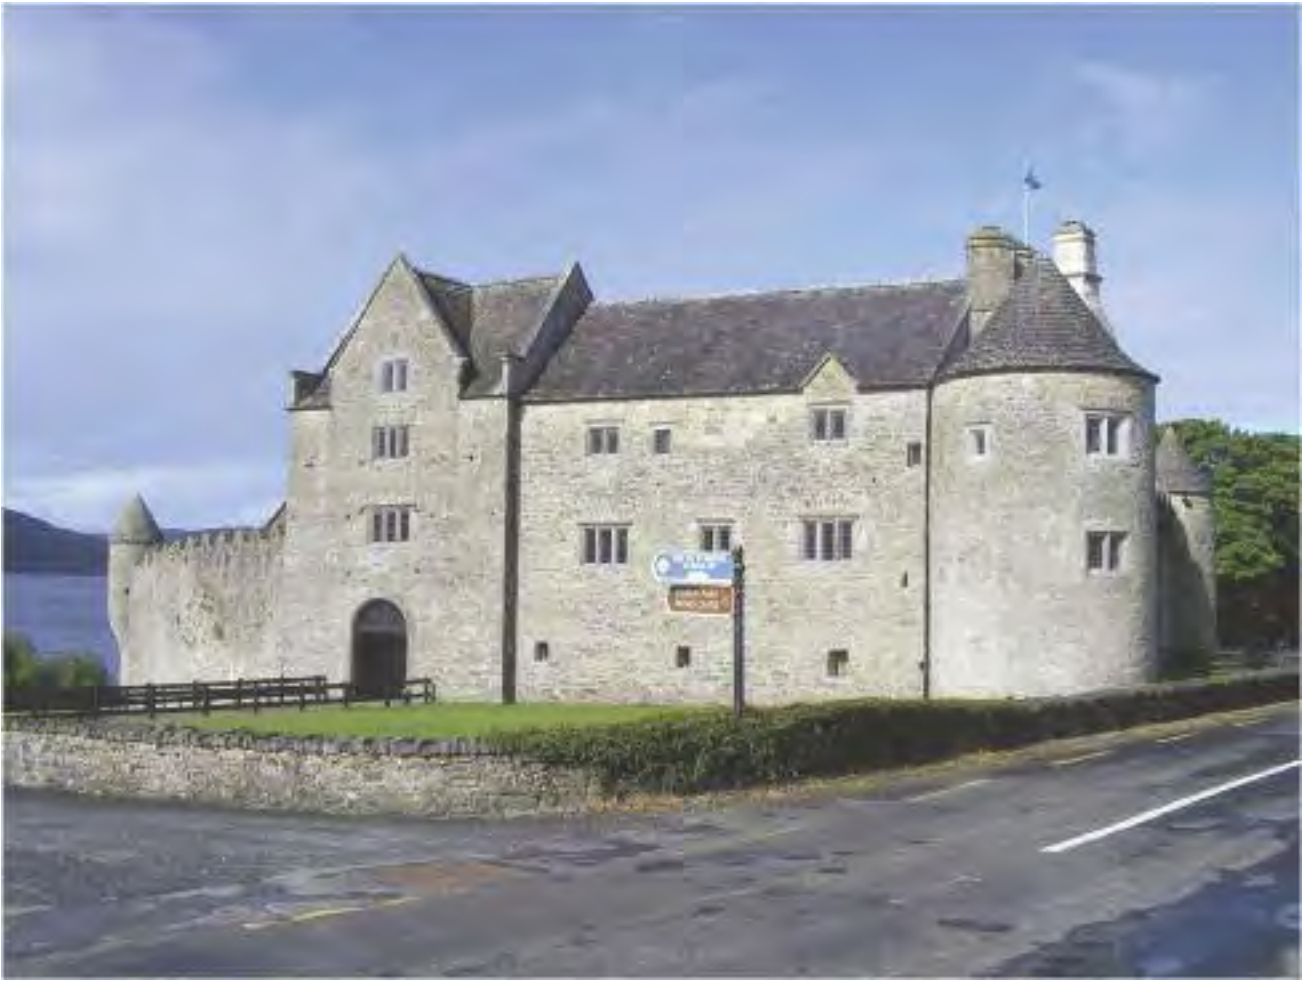
Pl. 3.2—Parke's Castle, Co. Leitrim, from the north-east (C. Donnelly).

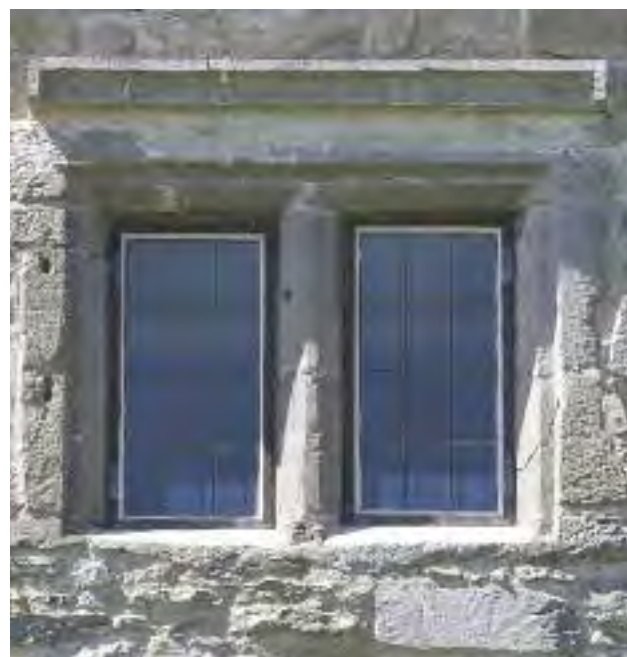
Pl. 3.11—Mullioned window in the eastern façade of the manor house, showing that the pieces have been reused from an earlier structure; note the presence of a bar-hole on the uppermost jamb stone to the left, and another set in the left side of the mullion (Photographic Unit, NMS).

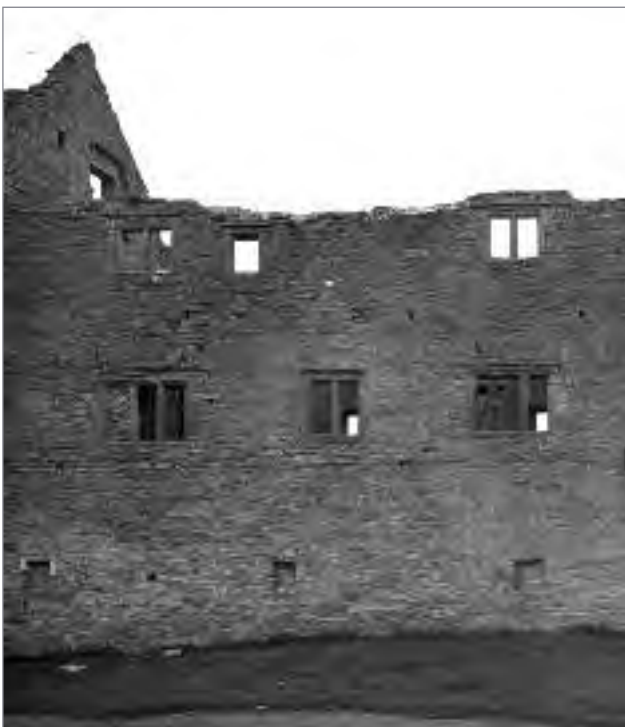
Pl. 3.12—Pre-conservation view of the exterior eastern façade of the manor house (Photographic Unit, NMS).

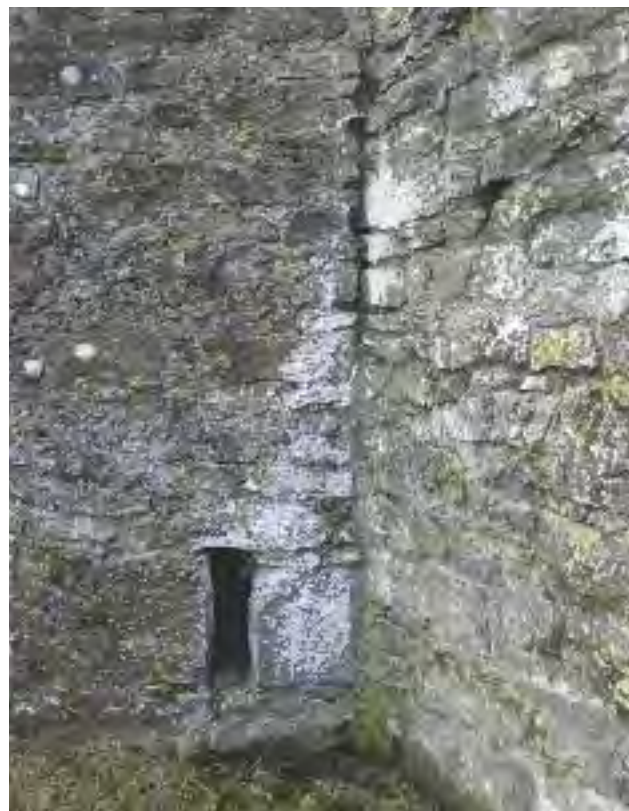
Pl. 3.17—The lack of bonding evident at the point where the north-east corner tower meets the northern bawn wall (Photographic Unit, NMS).

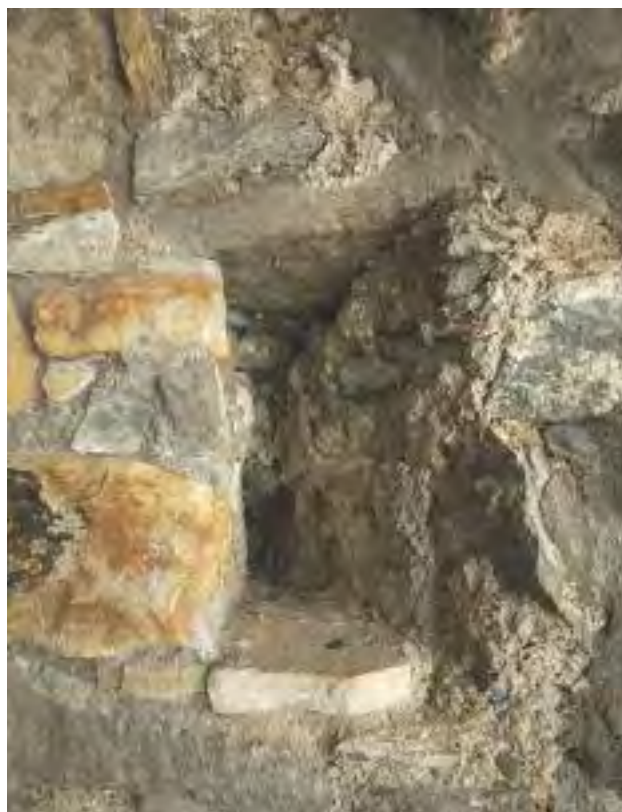
Pl. 3.25—Blocked gun loop at first-floor level within the north-west corner tower (Photographic Unit, NMS).

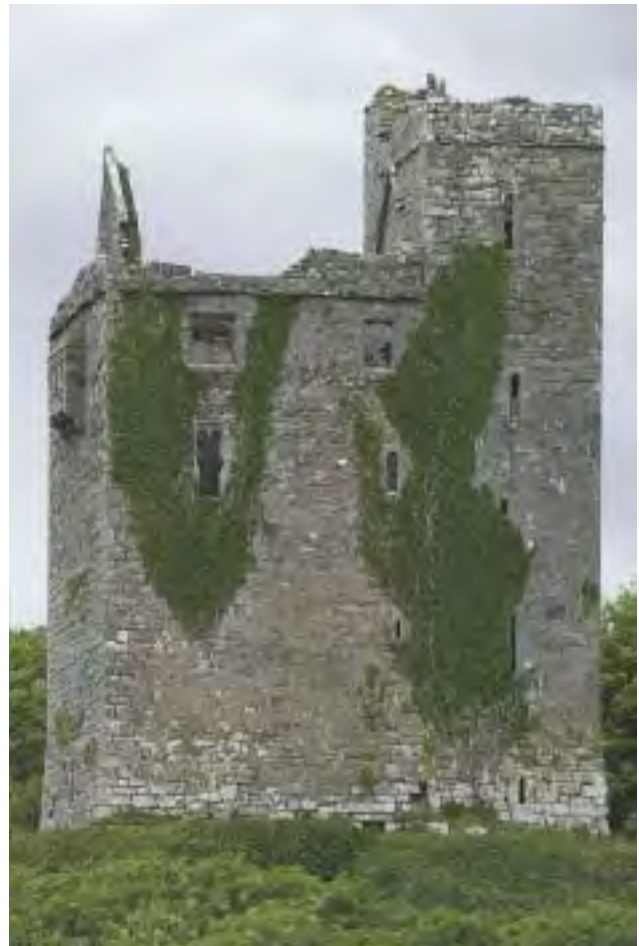
Pl. 3.26—Ballinalacken, Co. Clare, an example of a sectionally constructed tower-house (Photographic Unit, NMS).

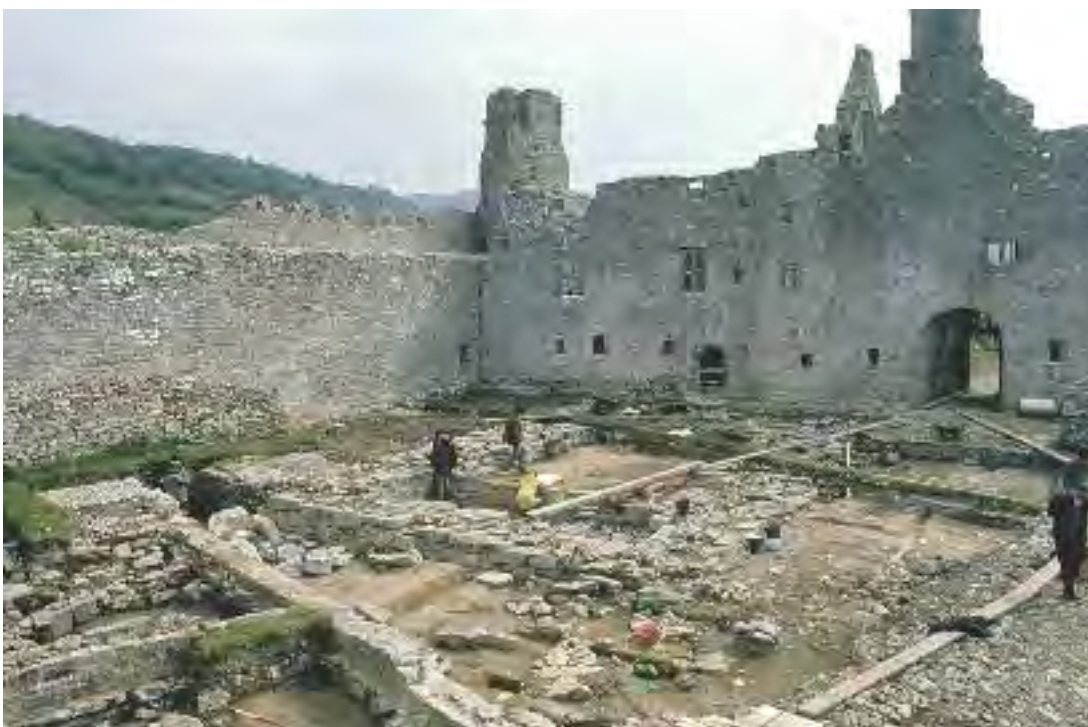
Pl. 4.2—View looking north-east, showing tower-house foundations at centre after some of the baulks dividing the area into small cuttings had been removed (Photographic Unit, NMS).

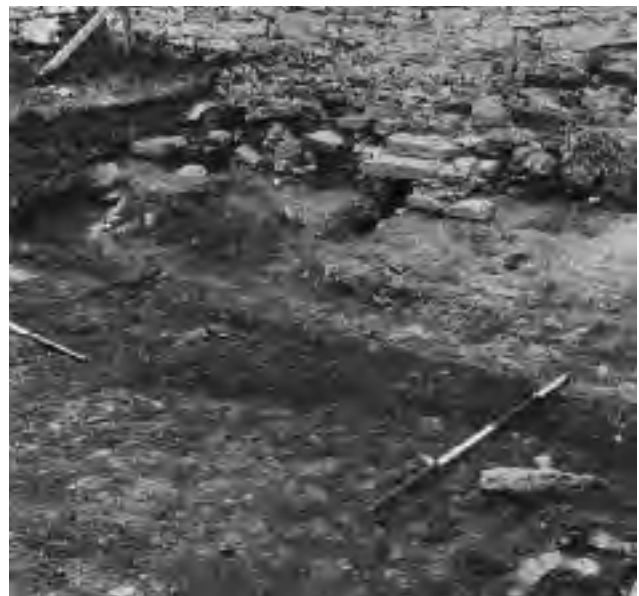
Pl. 4.7—MVIII: drain through bawn wall (C.MVIII30) and layer 3 (C.MVIII04), looking east (Photographic Unit, NMS).

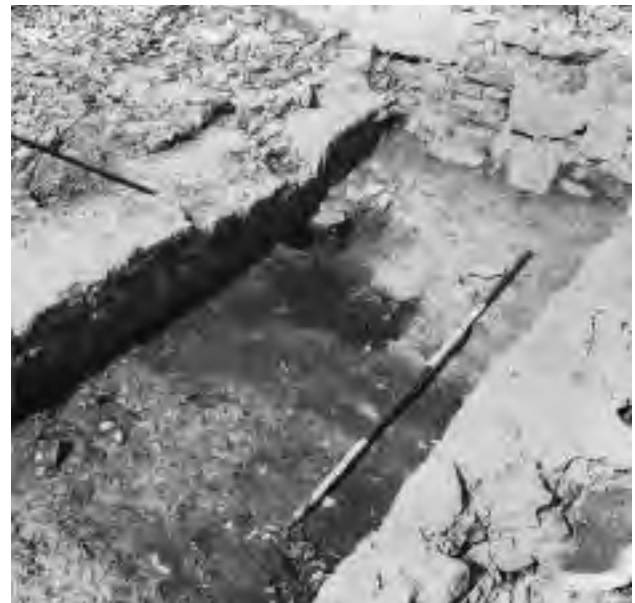
**Pl. 4.8**—Cutting 3: trench and hearth (C.211 and C.311), looking west (Photographic Unit, NMS).

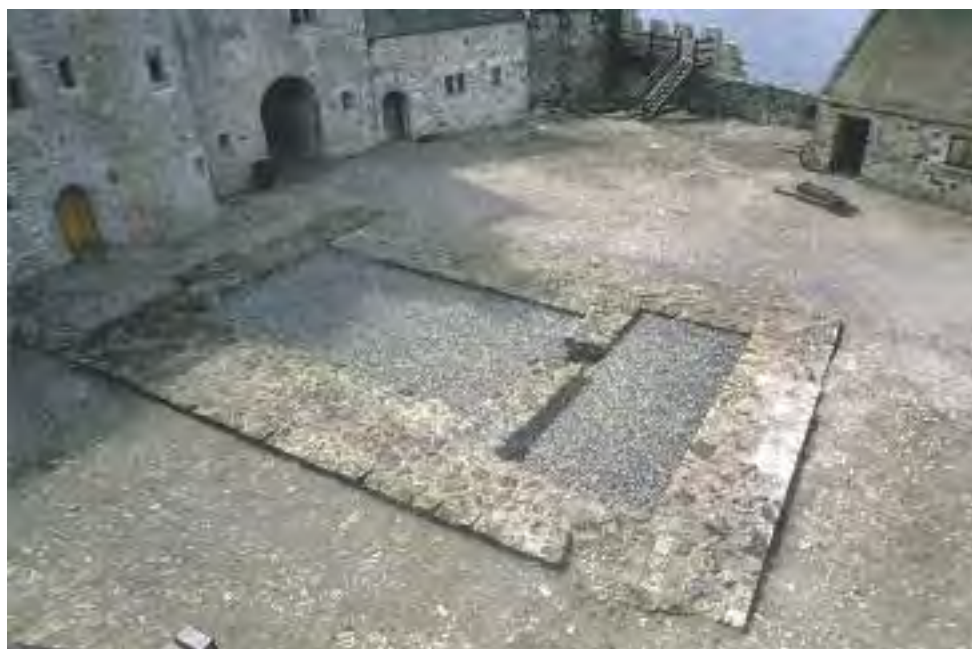
Pl. 4.9—View towards the south-west corner of the bawn interior, showing the foundations of the tower-house as displayed following completion of the conservation work (Photographic Unit, NMS).

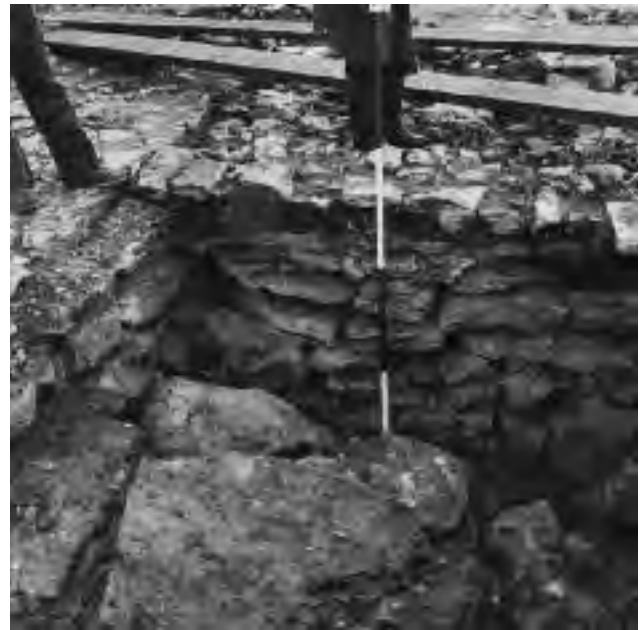
Pl. 4.14—The north-east corner of the eastern chamber in the main chamber block, showing its abutment against the wall of the building's subsidiary chamber section (Photographic Unit, NMS).

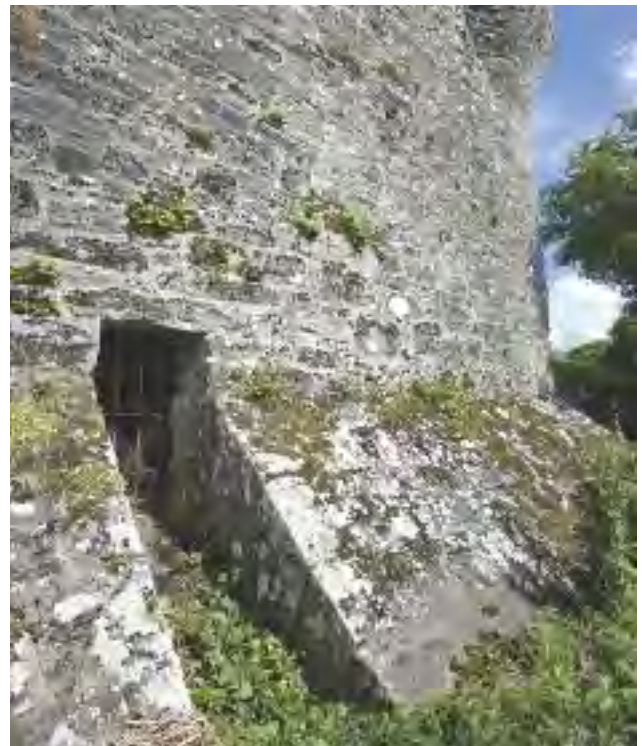
Pl. 4.21—The sally-port opening through the southern bawn wall and later wall batter, looking north-east from the lough shore (Photographic Unit, NMS).

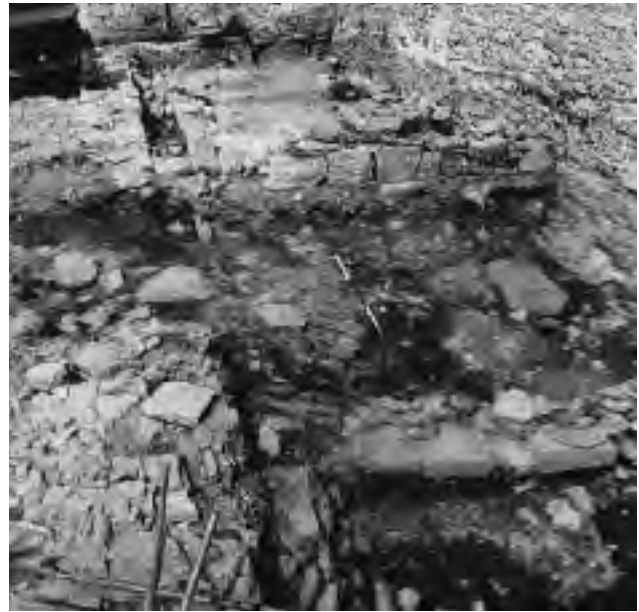
Pl. 4.25—Cuttings 24 and 34: the kitchen structure in the upper part of the picture against the south wall of the gatehouse and eastern bawn wall, looking north-east (Photographic Unit, NMS).

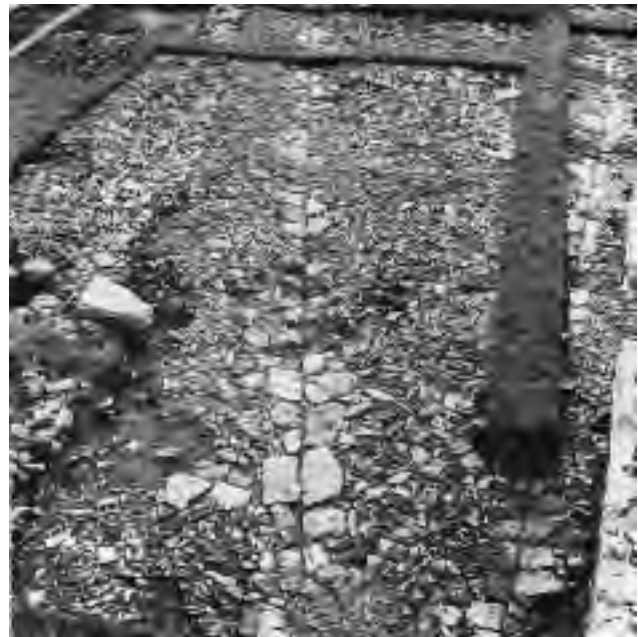
Pl. 4.26—Cutting 25: an open drain and associated cobbling, looking east (Photographic Unit, NMS).

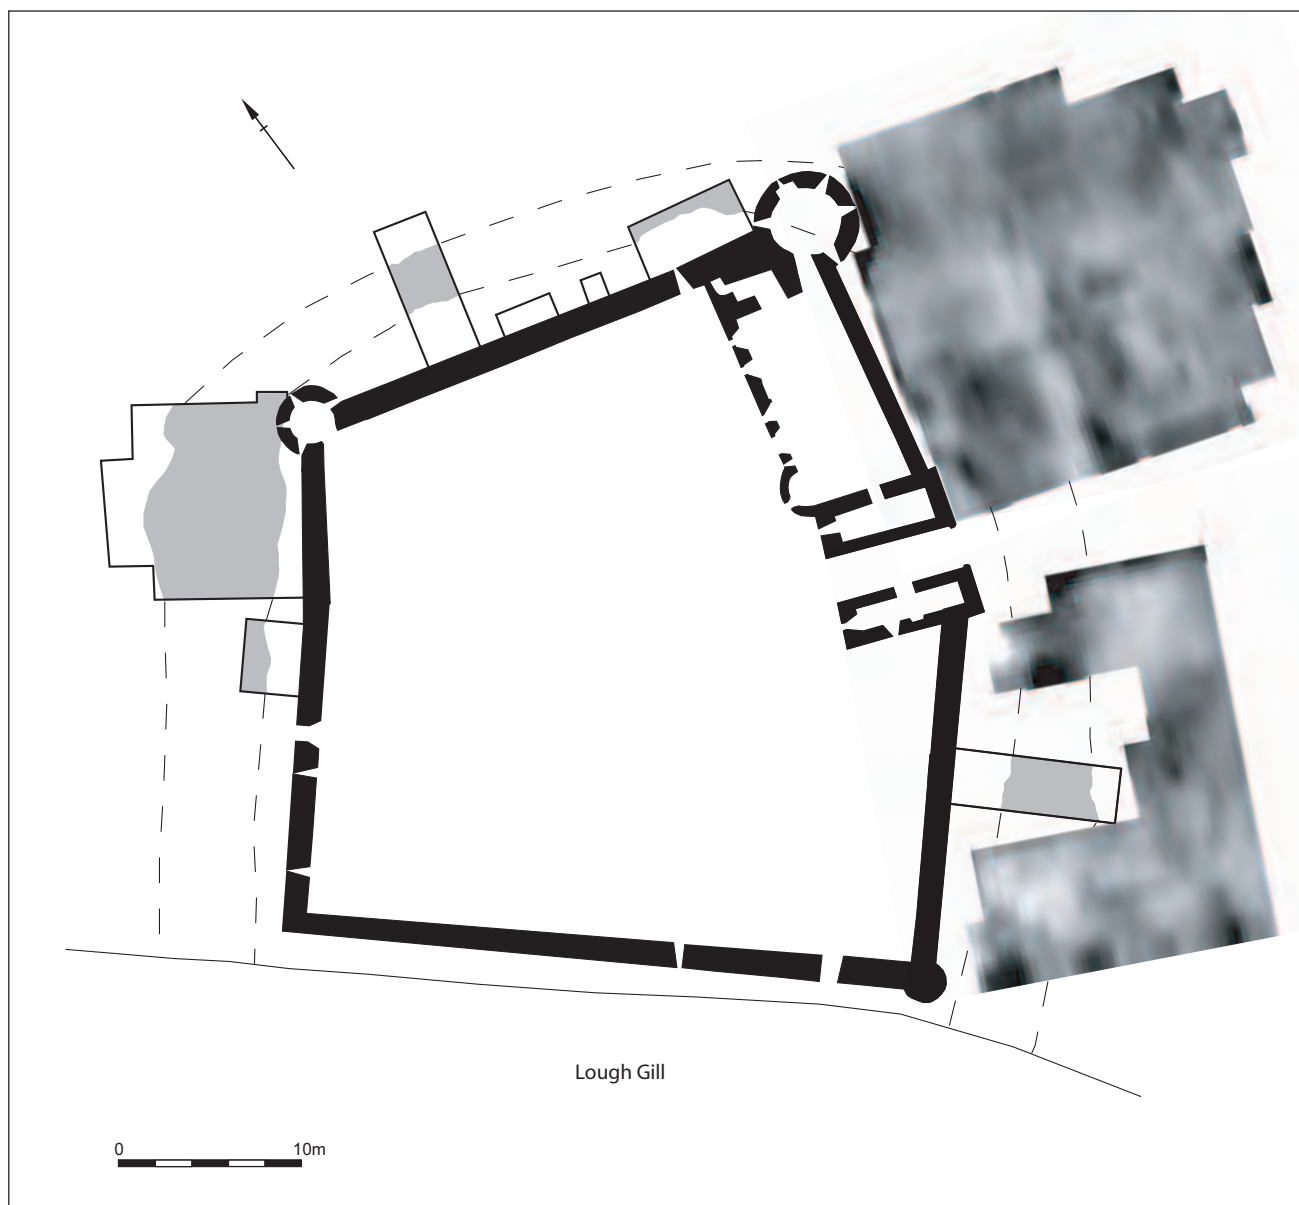
Fig. 4.12—Location of geophysical survey grids in relation to the castle.

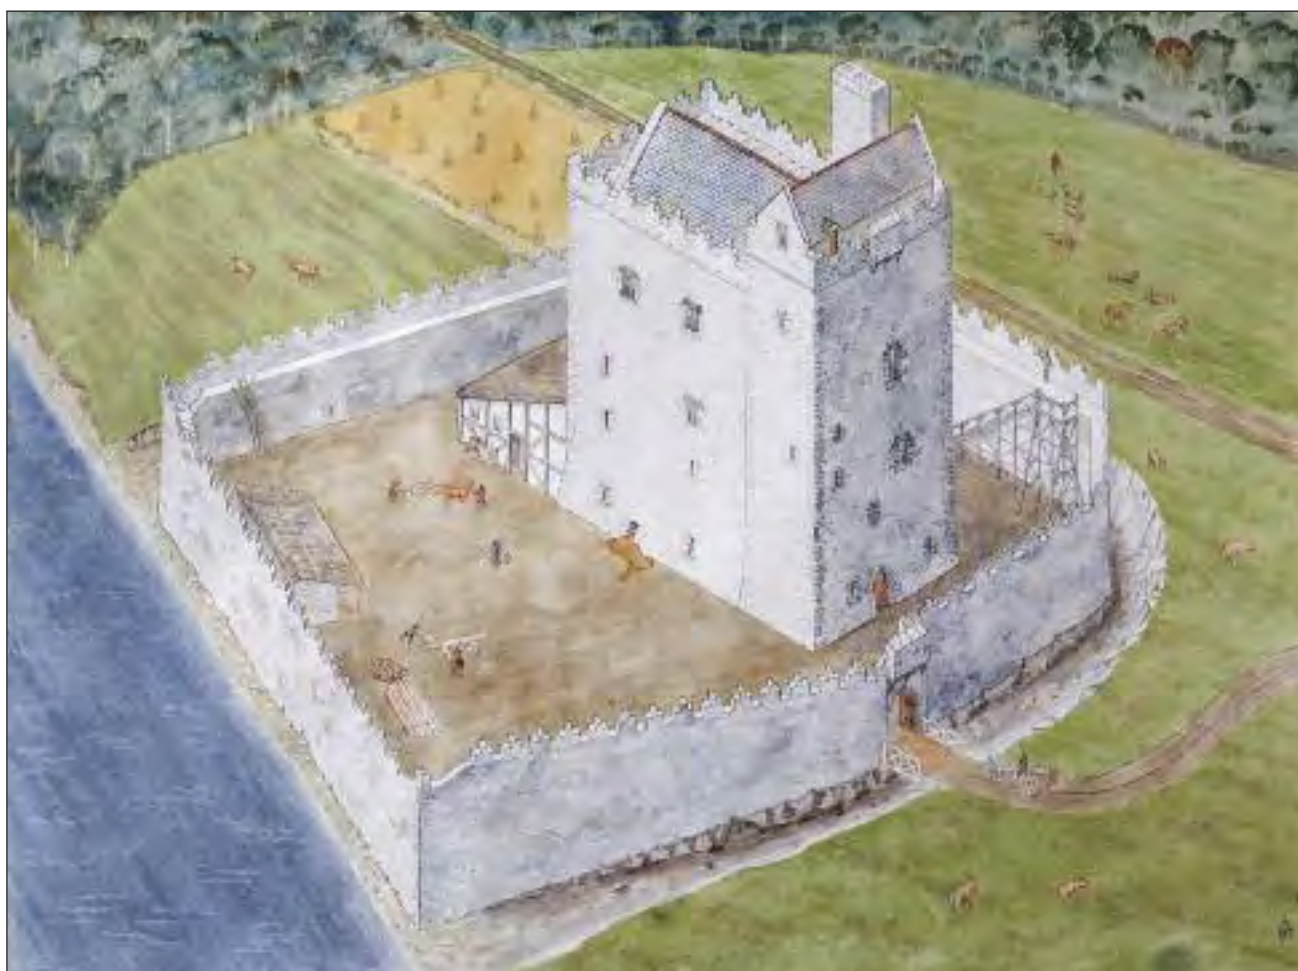
Fig. 6.1—Reconstruction drawing showing the late medieval phase of the site's occupation, c. 1550 (P. Manning).
